Durability Evaluation of
Aftermarket Catalysts

TECHNICAL REPORT DATA <i>(Please read Instructions on the reverse before completing)</i>		
1. REPORT NO. EPA/AA/CTAB/86-01	2.	PB 86-181740
4. TITLE AND SUBTITLE Durability Evaluation of Aftermarket Catalysts		5. REPORT DATE March 1986

Technical Report

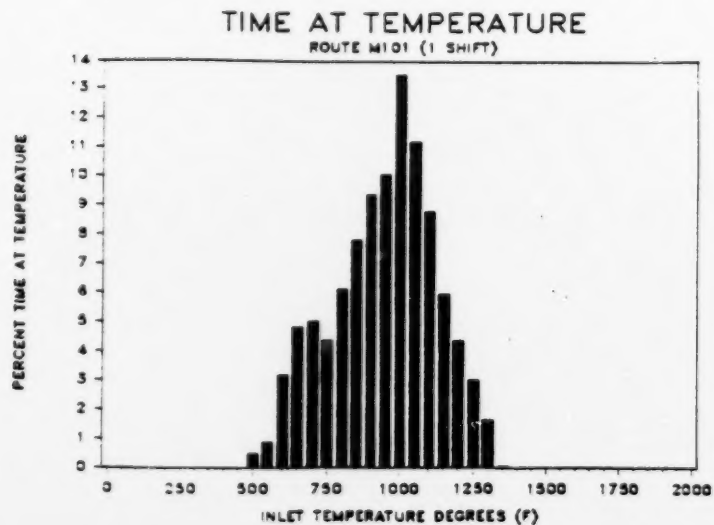
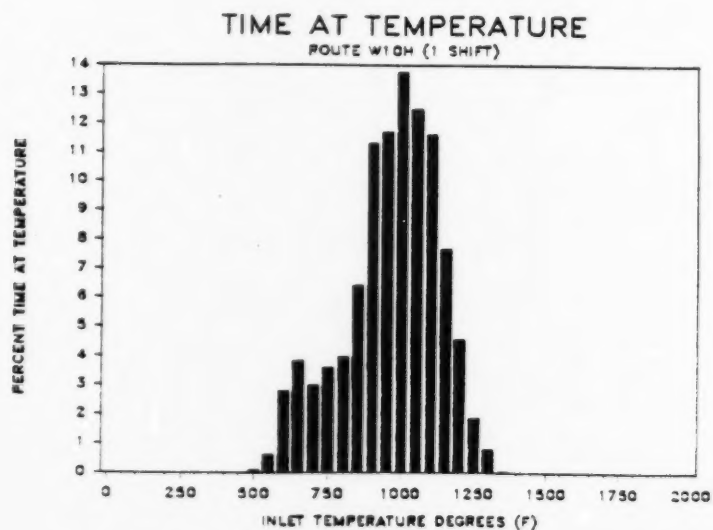
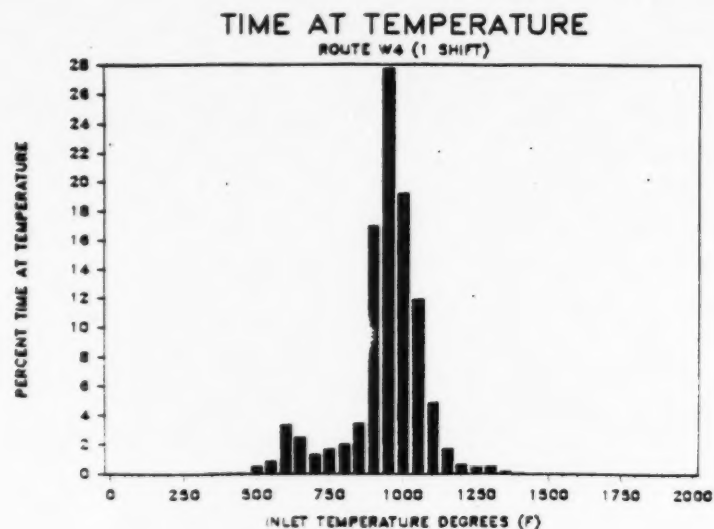
Figure 1 - Inlet Temperature Distributions
of Durability Routes

Plots of the distributions of the catalyst inlet and outlet temperatures are shown in Figures 1 and 2, respectively.

The three different routes did not result in significantly different catalyst temperatures. The catalyst outlet temperature distributions are more similar to each other than are the inlet temperature distributions. Note that the "hardest" route in terms of tire wear did not produce the highest catalyst temperatures.

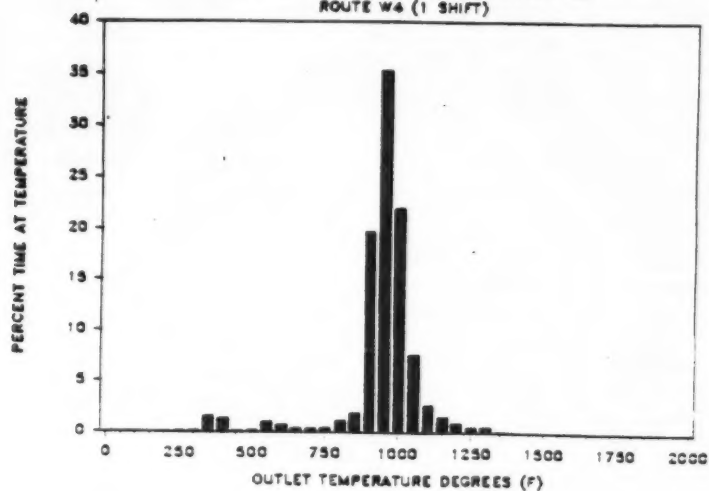
ROUTE W4 (1 SHIFT)

Figure 2 - Outlet Temperature Distributions
of Durability Routes
